## For Repair and Prevention of Corrosion Under Insulation (CUI)

## The Unconventional Alternative.

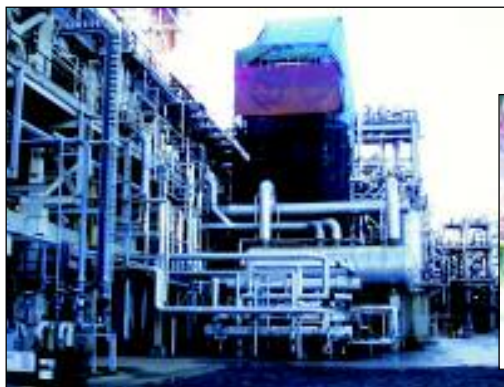
INSULATED INSTALLATION APPEARS SOUND

... UNDERNEATH - THE REALITY

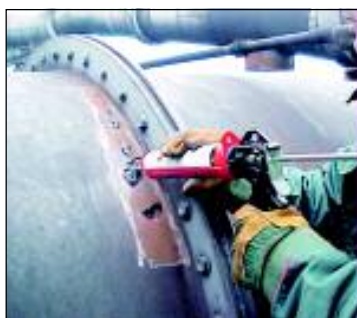
INFILL CORROSION PITS

**Belzona® 1251** - Rebuilding grade product designed to infill corrosion pitting and for bonding doubler plates over badly corroded areas.

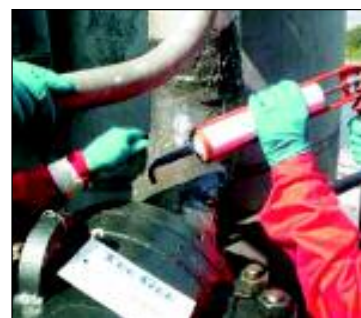
LOCAL REPAIR

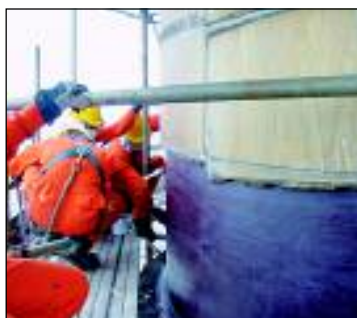
PROTECTION OF PROCESS VESSELS

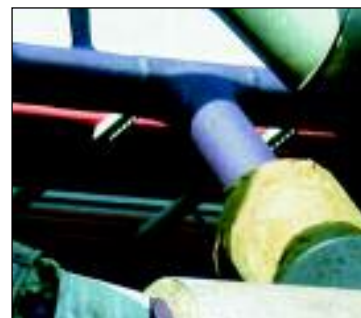
PROTECT PIPEWORK

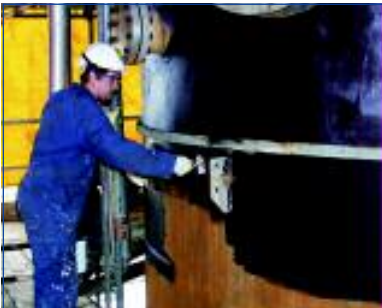
**Belzona® 5851** - Coating grade that provides outstanding corrosion protection.
